Manhole Inspection Summary

Manhole # S41C__006MH

Insp Date: **11/24/08 10:22 AM**

Location Address: **200-222 silver ct**

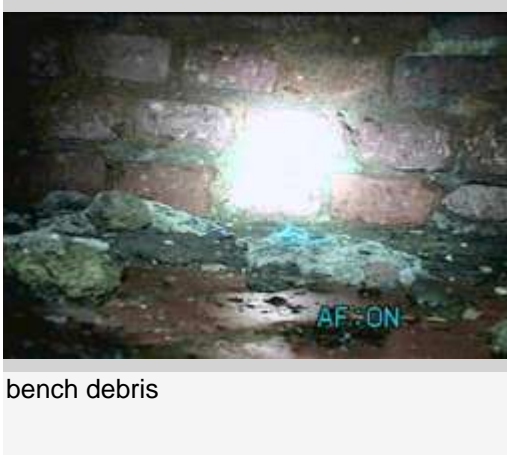
MISC

bench debris

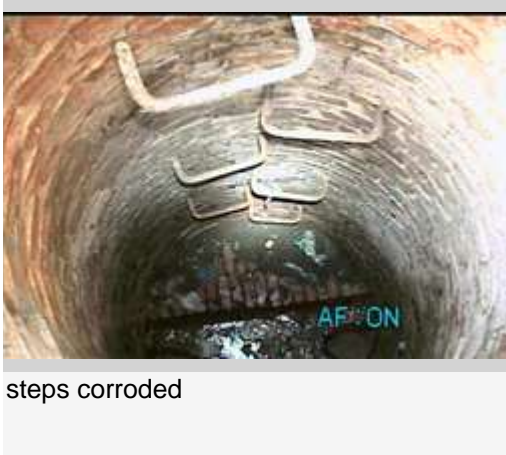
Defect 1

Count: **6** Missing: **0** ☒ **Corroded**

steps corroded

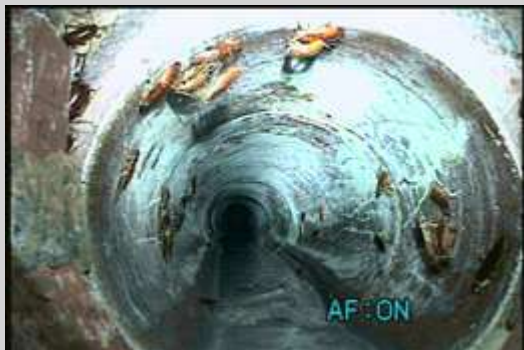
12 O'Clock Outflow

8 in. Circular Gravity Sewer
Pipe Out @ 12 O'Clock

Invert Depth: **10.88** (ft.) Flow Characteristics: **Slow**

Infiltration: **None** Pipe Seal Cond: **Unknown**

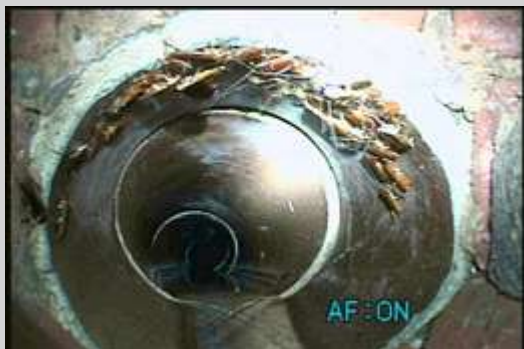
6 O'Clock Inflow

8 in. Circular Gravity Sewer
Pipe In @ 6 O'Clock

Invert Depth: **10.83** (ft.) Flow Characteristics: **Slow**

Infiltration: **None** Pipe Seal Cond: **Unknown**

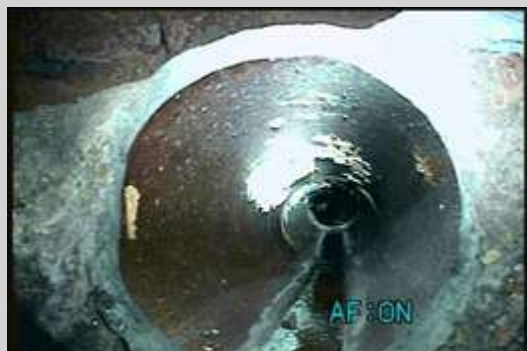
8 O'Clock Inflow

8 in. Circular Gravity Sewer
Pipe In @ 8 O'Clock

Invert Depth: **10.75** (ft.) Flow Characteristics: **Slow**

Infiltration: **None** Pipe Seal Cond: **Unknown**

Connects To: **Dead End**
